August 22, 2015

RE: 275-Gallon #2 Fuel Oil Aboveground Storage Tank (AST) Inspection

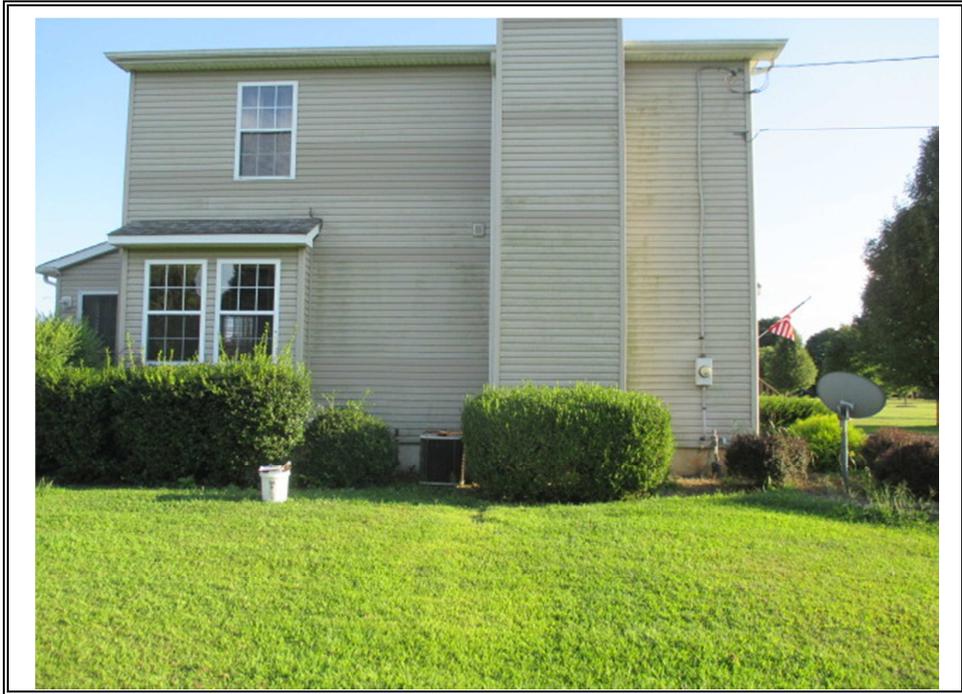
Photo 1: View looking south from the north side yard. The AST is located in the basement along the north wall. The vent and fill pipe are located behind the AC condenser.

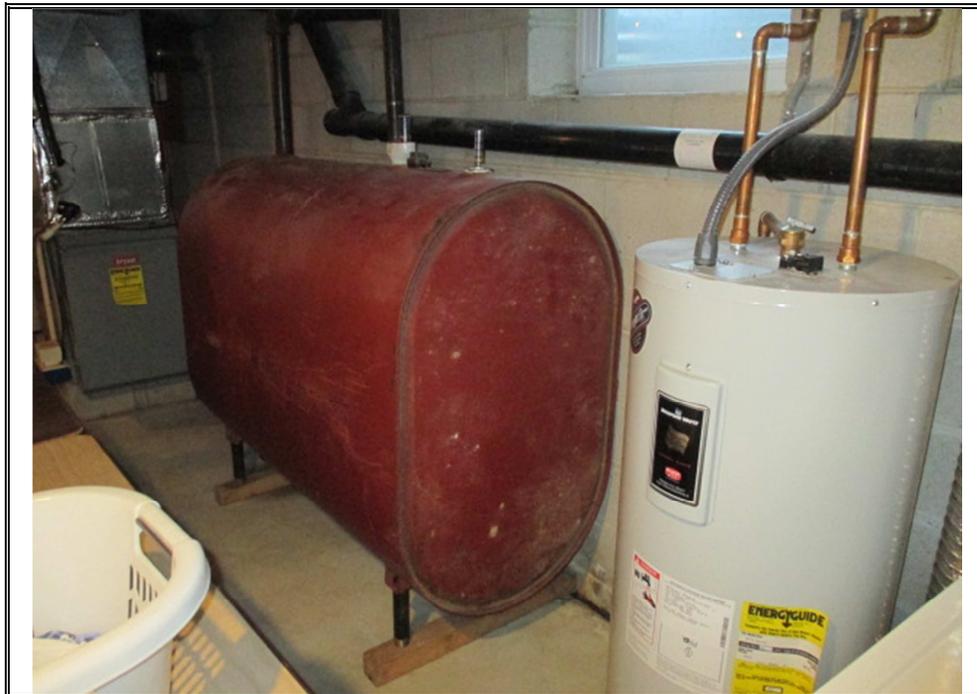
Photo 2: The AST is located between the furnace and the electric water heater. It is a standard indoor 12-gauge single-wall steel tank with a storage capacity of 275 gallons.

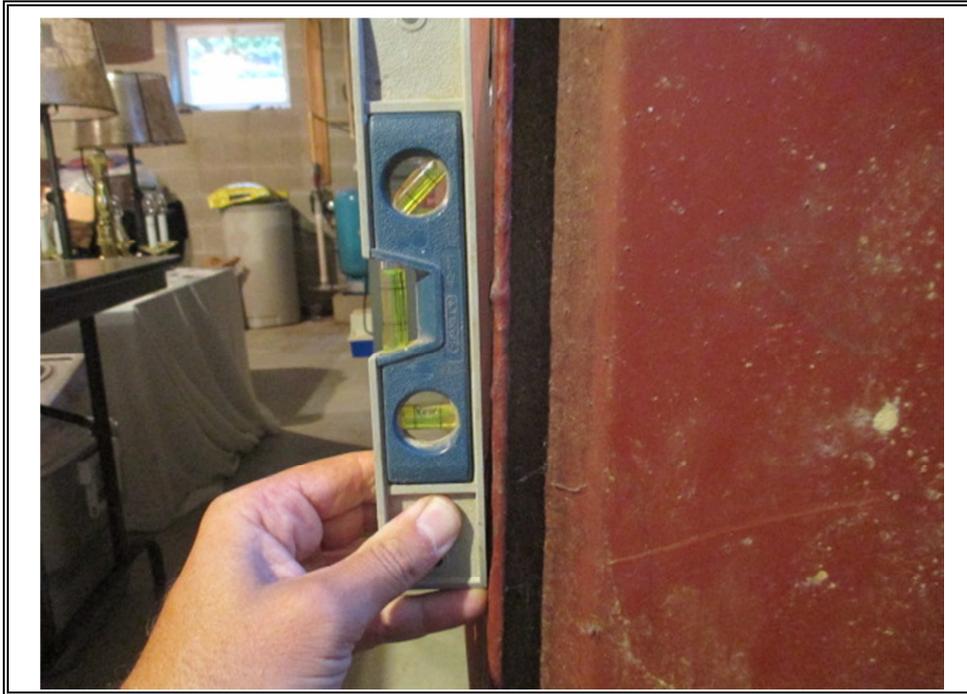
Photo 3: The tank is plumb east to west but leaning slightly north toward the basement wall.

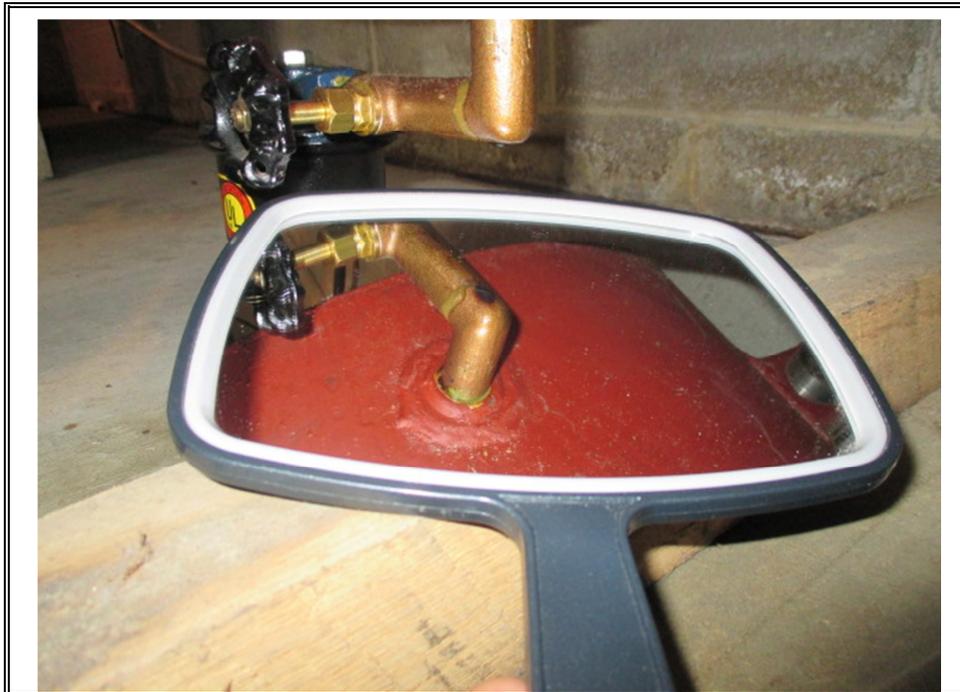
The tank system was first inspected for indications of product loss associated with leaks or fuel deliveries. With the exception of a slight oil drip around the bottom bung where the fitting for the oil supply line connects to the tank, no oil staining was observed on the tank exterior or piping. No oil staining or petroleum odors were evident outside by the fill and vent pipes. No dead or stressed vegetation was found around the fill or vent, which would be indicative of past delivery spills or tank overfills.

Photo 4: With the exception of a slight oil drip around the bottom bung where the fitting for the oil supply line connects to the tank, no oil staining was observed on the tank exterior or piping.

While limited to a few small oil drops, the leak around the bottom bung should be inspected by a qualified service technician to verify the integrity of the fitting and its connection to the tank.

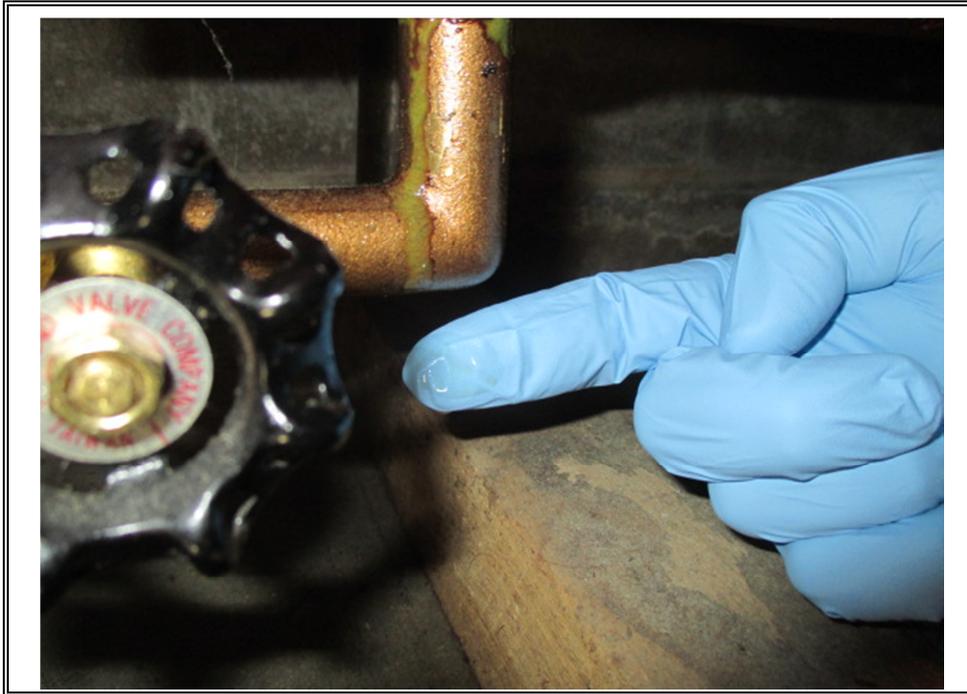
Photo 5: The connecting fitting was covered with oil (sheen on glove and brass).

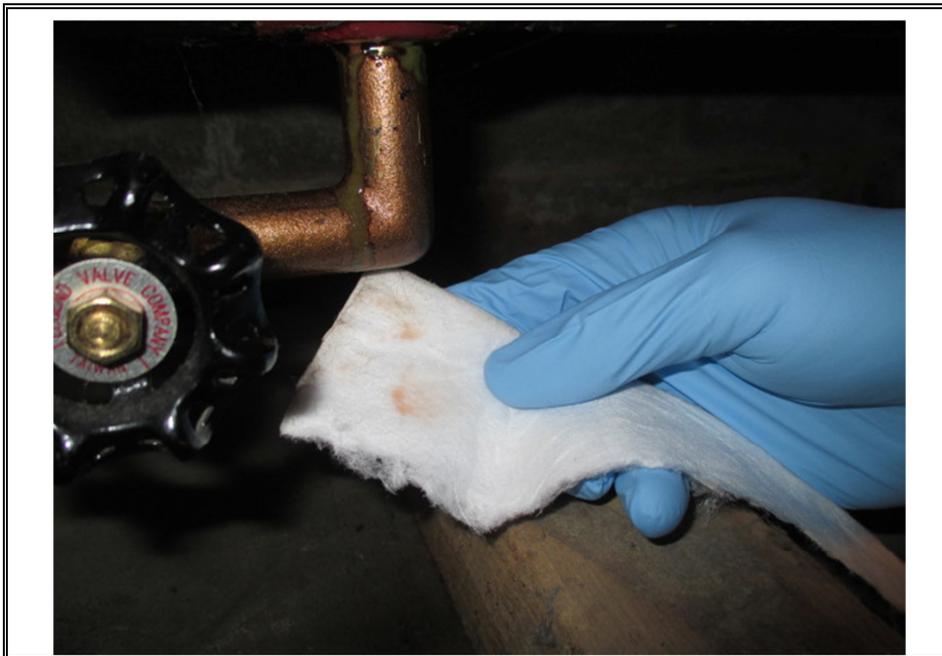
Photo 6: Confirmation that the dark droplets visible in photo 4 beneath the 90 and around the bung are oil; red dye is visible on the absorbent cloth. While limited to a few droplets, the leak around the bottom bung should be inspected by a qualified service technician to verify the integrity of the fitting and its connection to the tank.

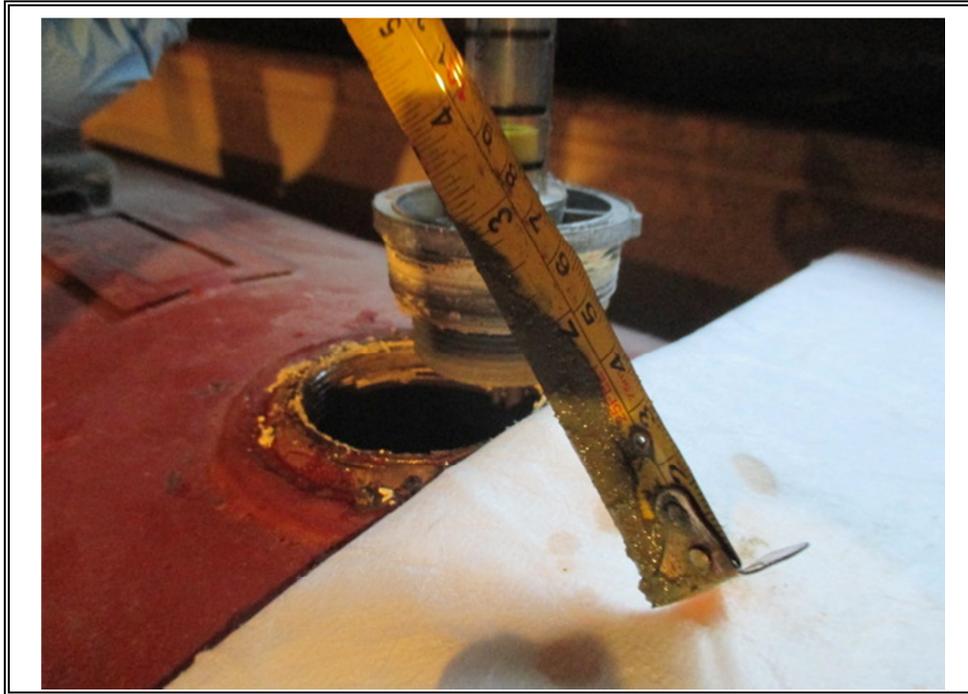
The tank is equipped with two fill gauges but neither one are working. The AST contained approximately 37.5 inches of oil, about 245 gallons, at the time of the inspection. While a working oil gauge is not necessary during fuel delivery, a fuel gauge is a critical component of the tank system and should function properly.

Photo 7: The AST was checked for fuel volume and water through the east bung. No water was detected in the tank, which contained about 245 gallons of oil. The fill gauge is not working and should be replaced.

The fill gauge installed in the east bung should be replaced with a working gauge.

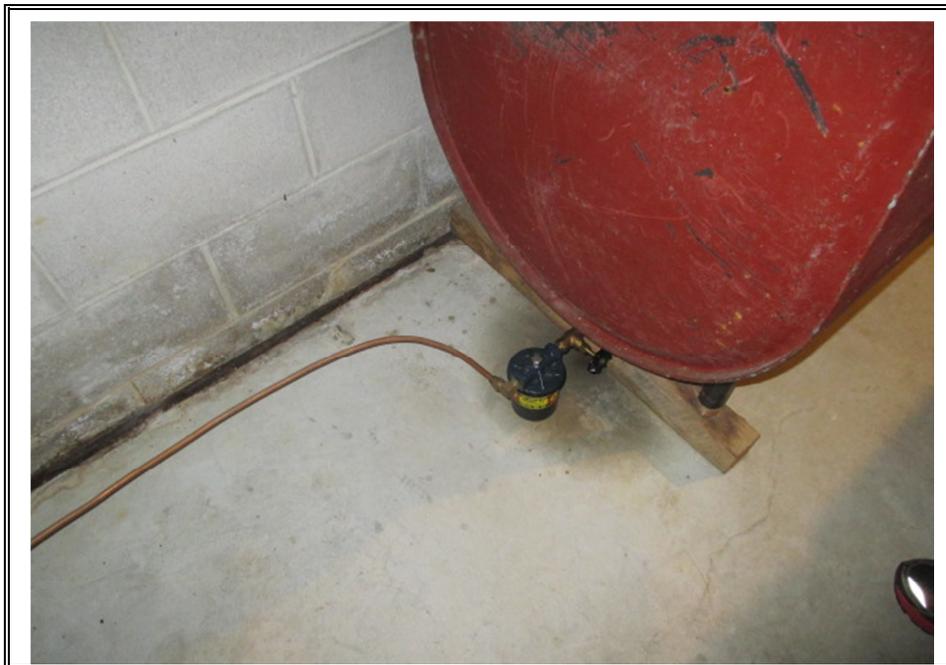
Photo 8: Oil supply line and filter. Some older staining was visible under the filter and likely related to routine service. No leaks were visible around the filter housing. Both the copper line and the filter are vulnerable to accidental breakage and could be snapped off the tank if stepped on or struck sharply. Care should be taken if any activity occurs near the supply line.

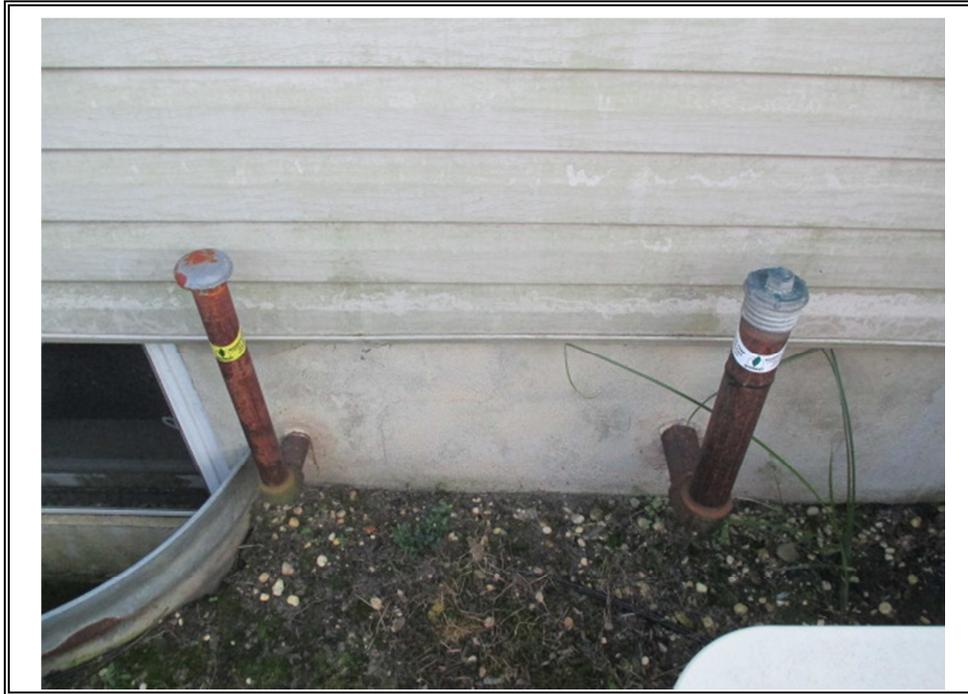
Photo 9: Two-inch diameter oil fill with scully cap (right side of photo) and 1.25-inch diameter vent with screened cap (left side of photo). Both pipes drain freely back to the tank.

Ideally the vent and fill pipe would be the same diameter to minimize the risk of over pressurization during filling. The existing setup appears to be functioning properly but routine inspections of the vent cap are recommended to make sure it remains free of debris (insect, ice, etc.). Although a minimal length, the oil supply line and oil filter are susceptible to accidental breakage and care should be taken when activity occurs near the line. Periodic inspection of the wooden support is recommended to make sure the boards are solid and the tank is not shifting.

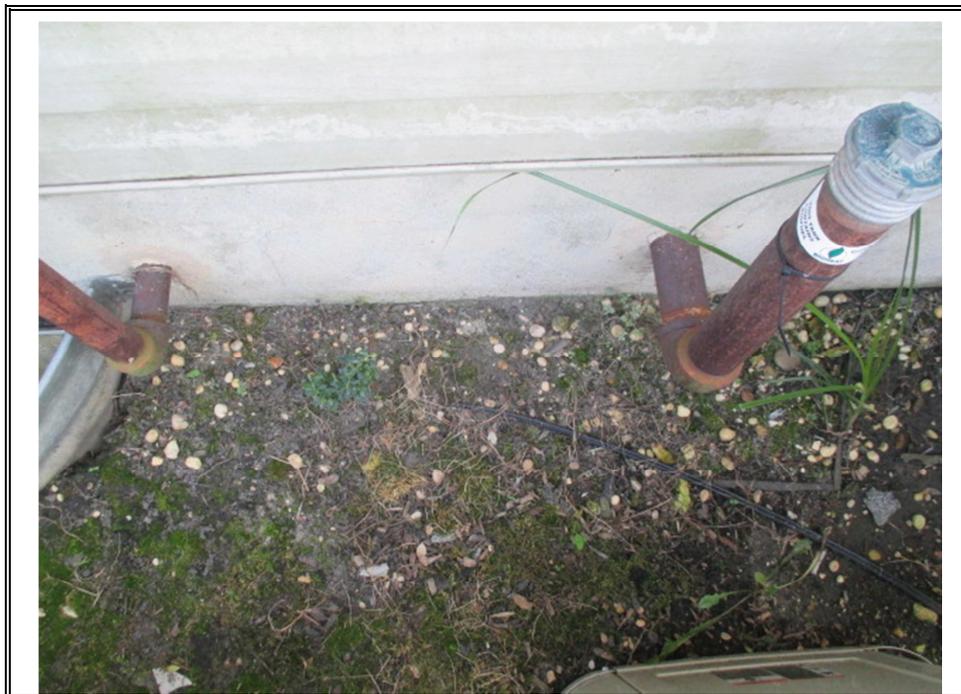
Photo 10: No oil staining or petroleum odors were evident outside by the fill and vent pipes. No dead or stressed vegetation indicative of past delivery spills or tank overfills was found around the fill or vent.
